Church Fenton

Historic Environment Appraisal

Church Fenton Heritage Significance - Initial Report

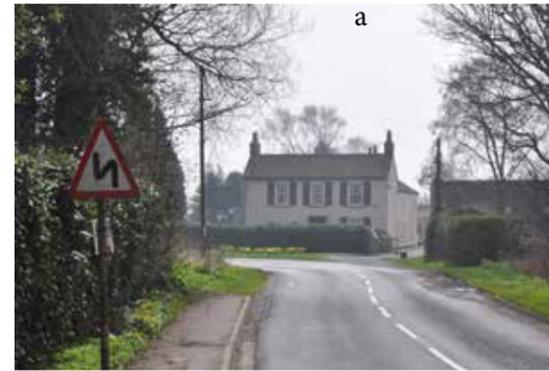
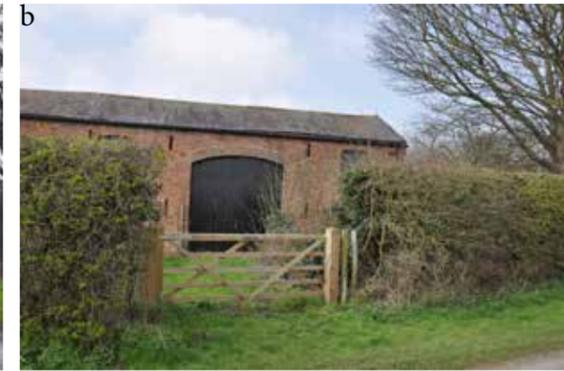
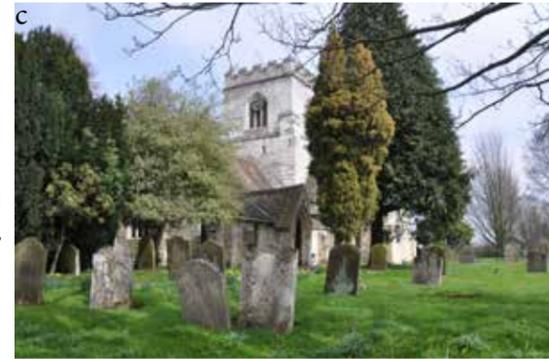
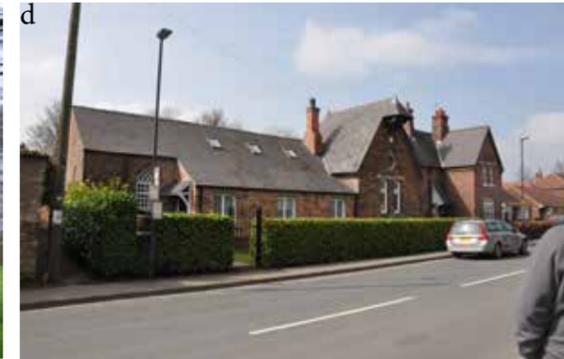
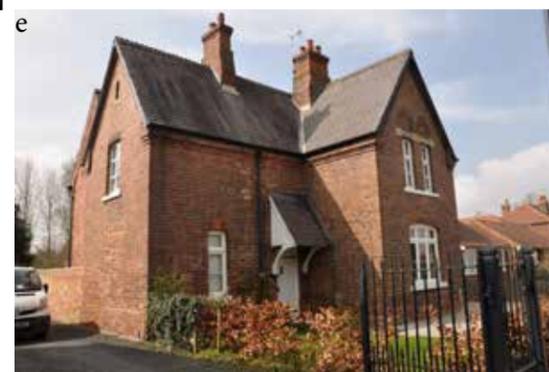
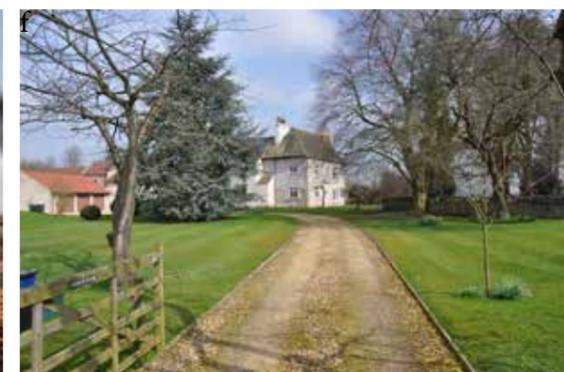
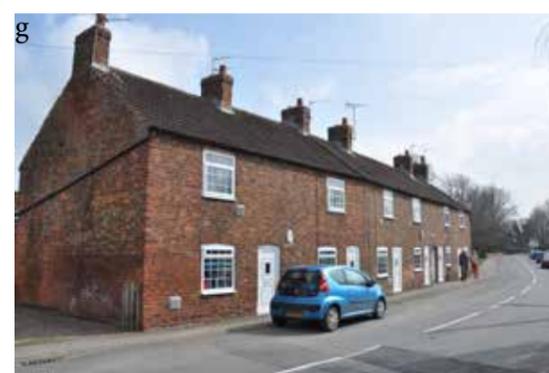
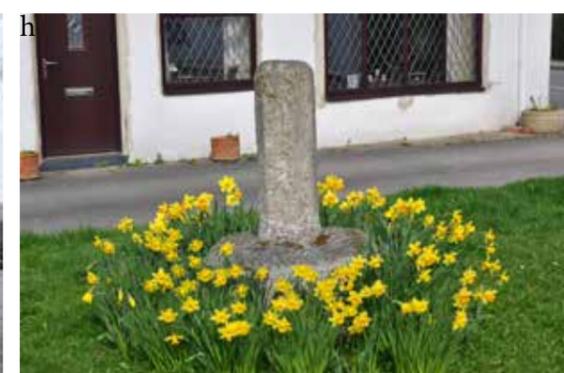
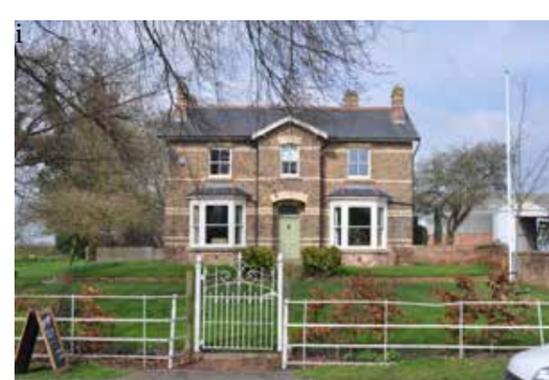
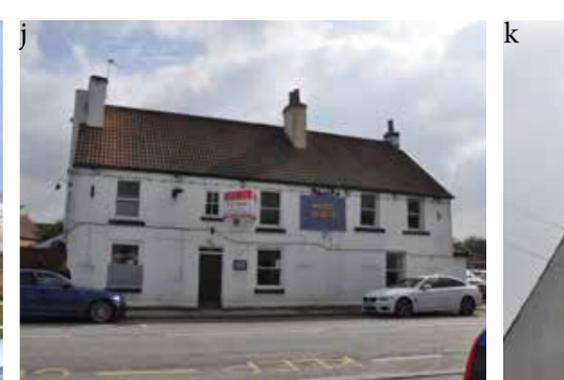
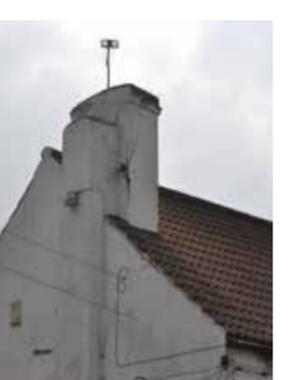
a/b) Church End Farm. An interesting historic cluster of buildings forming the distinct end of the village from the South. c) St Mary's Church. d/e) Former Church Fenton School and schoolmasters house. (now residential). f) The Croft timber frame building of substantial status. g) 'Chicory Row', Church Street. h) Remnants of Church cross, Church Street. i) Manor Farm house, Main Street. j/k) The White Horse pub. NB the off set chimney, a potential indicator of an earlier timber frame building, later encased.

Church End Farm, Church Street: Good survival of barns and farmhouse facing north along Church Street. Front of farmhouse would appear to be 18th/19th century but older, possibly medieval building extant to the rear. There is some suggestion that the building may be later encasement of an historic house.

Church of St Mary, Church Street: Grade I Listed cruciform church dating from 1230. An exceptionally important building. (for more info see Listed Building Description).

Former Church Fenton Primary School, Church Street: 19th century school building and school masters house (documents relating to its commission in National Archives.)
Village Church Cross, Church Street. Grade II Listed Medieval cross with base and lower level upon small village green. Recorded by Speight in 19th century.

The Croft, Church Street. Grade II Listed 16th century or earlier timber framed house with outbuildings and later 18th century additions adjacent to church.

1-6 Church Street 'Chicory Row'. Early 19th century cottages with alleged connections to Irish settlers and Chicory agriculture in the local area, labelled as 'Roman Terrace' on the 1847 OS map but it is unclear why. Modified with UPVC windows.

The White Horse Public House, Main Street. White Horse Inn. Shown on the 1847 Ordnance Survey plan and recorded in Civil War accounts from 17th century. White rendered building (presumably to cover up later additions) with shallow reveal sash windows to main range. It would appear that there are three phases to this building and the earliest phase could be quite early and possibly timber framed (due to off centre chimneys). Appears to have been extended in Georgian period with later, Victorian, extensions to the rear. A potentially early

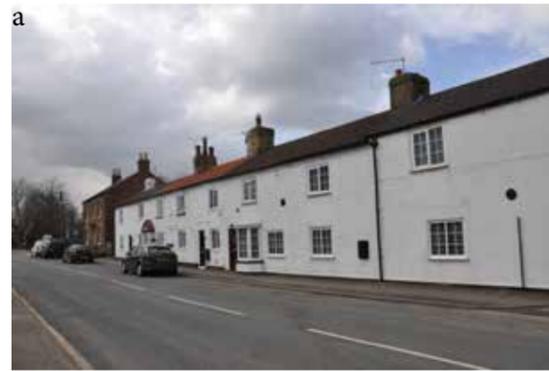
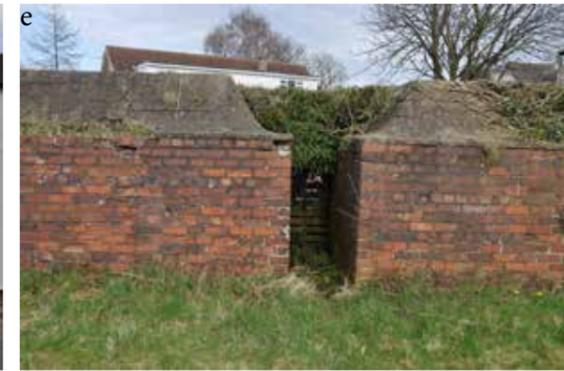
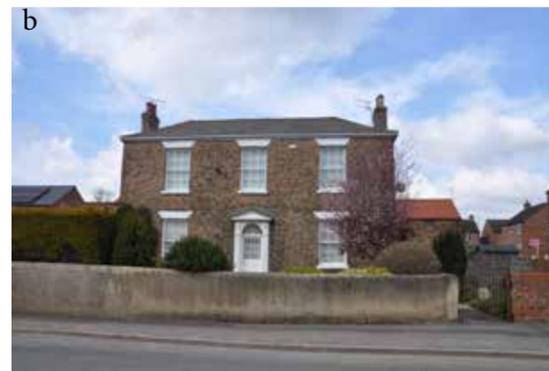
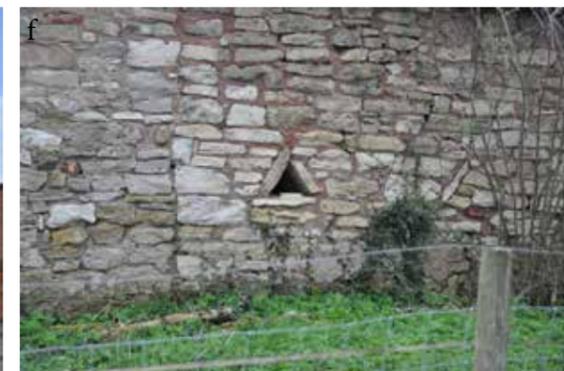
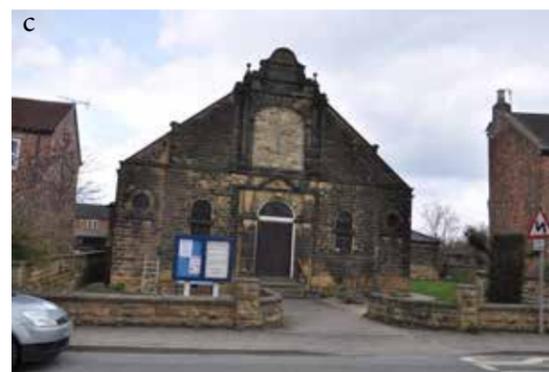
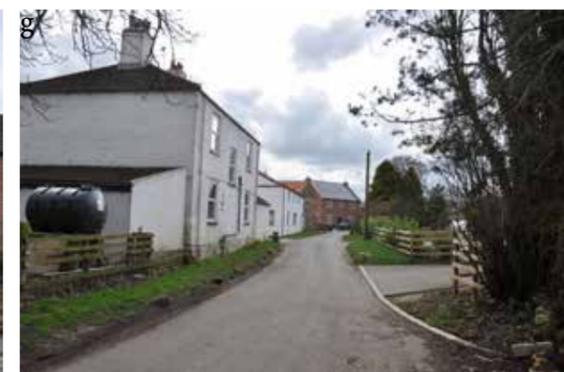
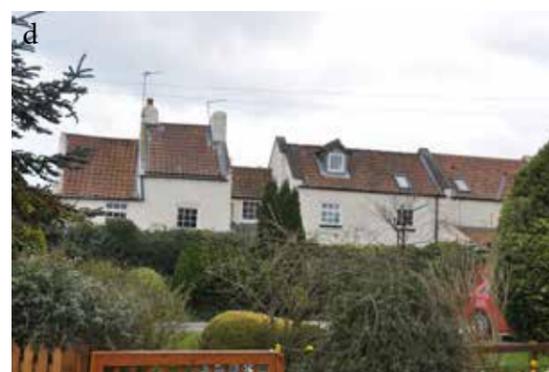
a) Cottages on Main Street. b) Georgian House (Grade II Listed) on Main Street - a classic example of 18th century farmhouse. c) Church Fenton Methodist Church (now residential) d) Properties of some antiquity to the east end of Main Street. e) Second World War shelter along Nanny Lane. f) Possible early barn containing interesting feature that may date from 17th century if not earlier. g) Hall Lane.

Cottages, Main Street. Row of cottages, formerly one unit was a bank. Possibly late 18th/early 19th century date and forming a distinctive form of cottages within the heart of the village.

Former Methodist Chapel, Main Street. Late 19th Century former Methodist chapel provides an interesting focal point within the street scene and reflects the religious and cultural changes brought to the village around this time.

There would appear to be an interesting story here and the lines of roads, open spaces and extant buildings all contribute to the significance of the village as a whole. All structures are non designated and with fairly significant change having occurred. Nevertheless this part of the village still retains its rural 'feel'. Older buildings such as barns and potential remnants of the Hall and Tythe Barn with potential historic links to the west over fields all contribute to this significance. Several buildings appear to have stone elements which may relate to their older origins.

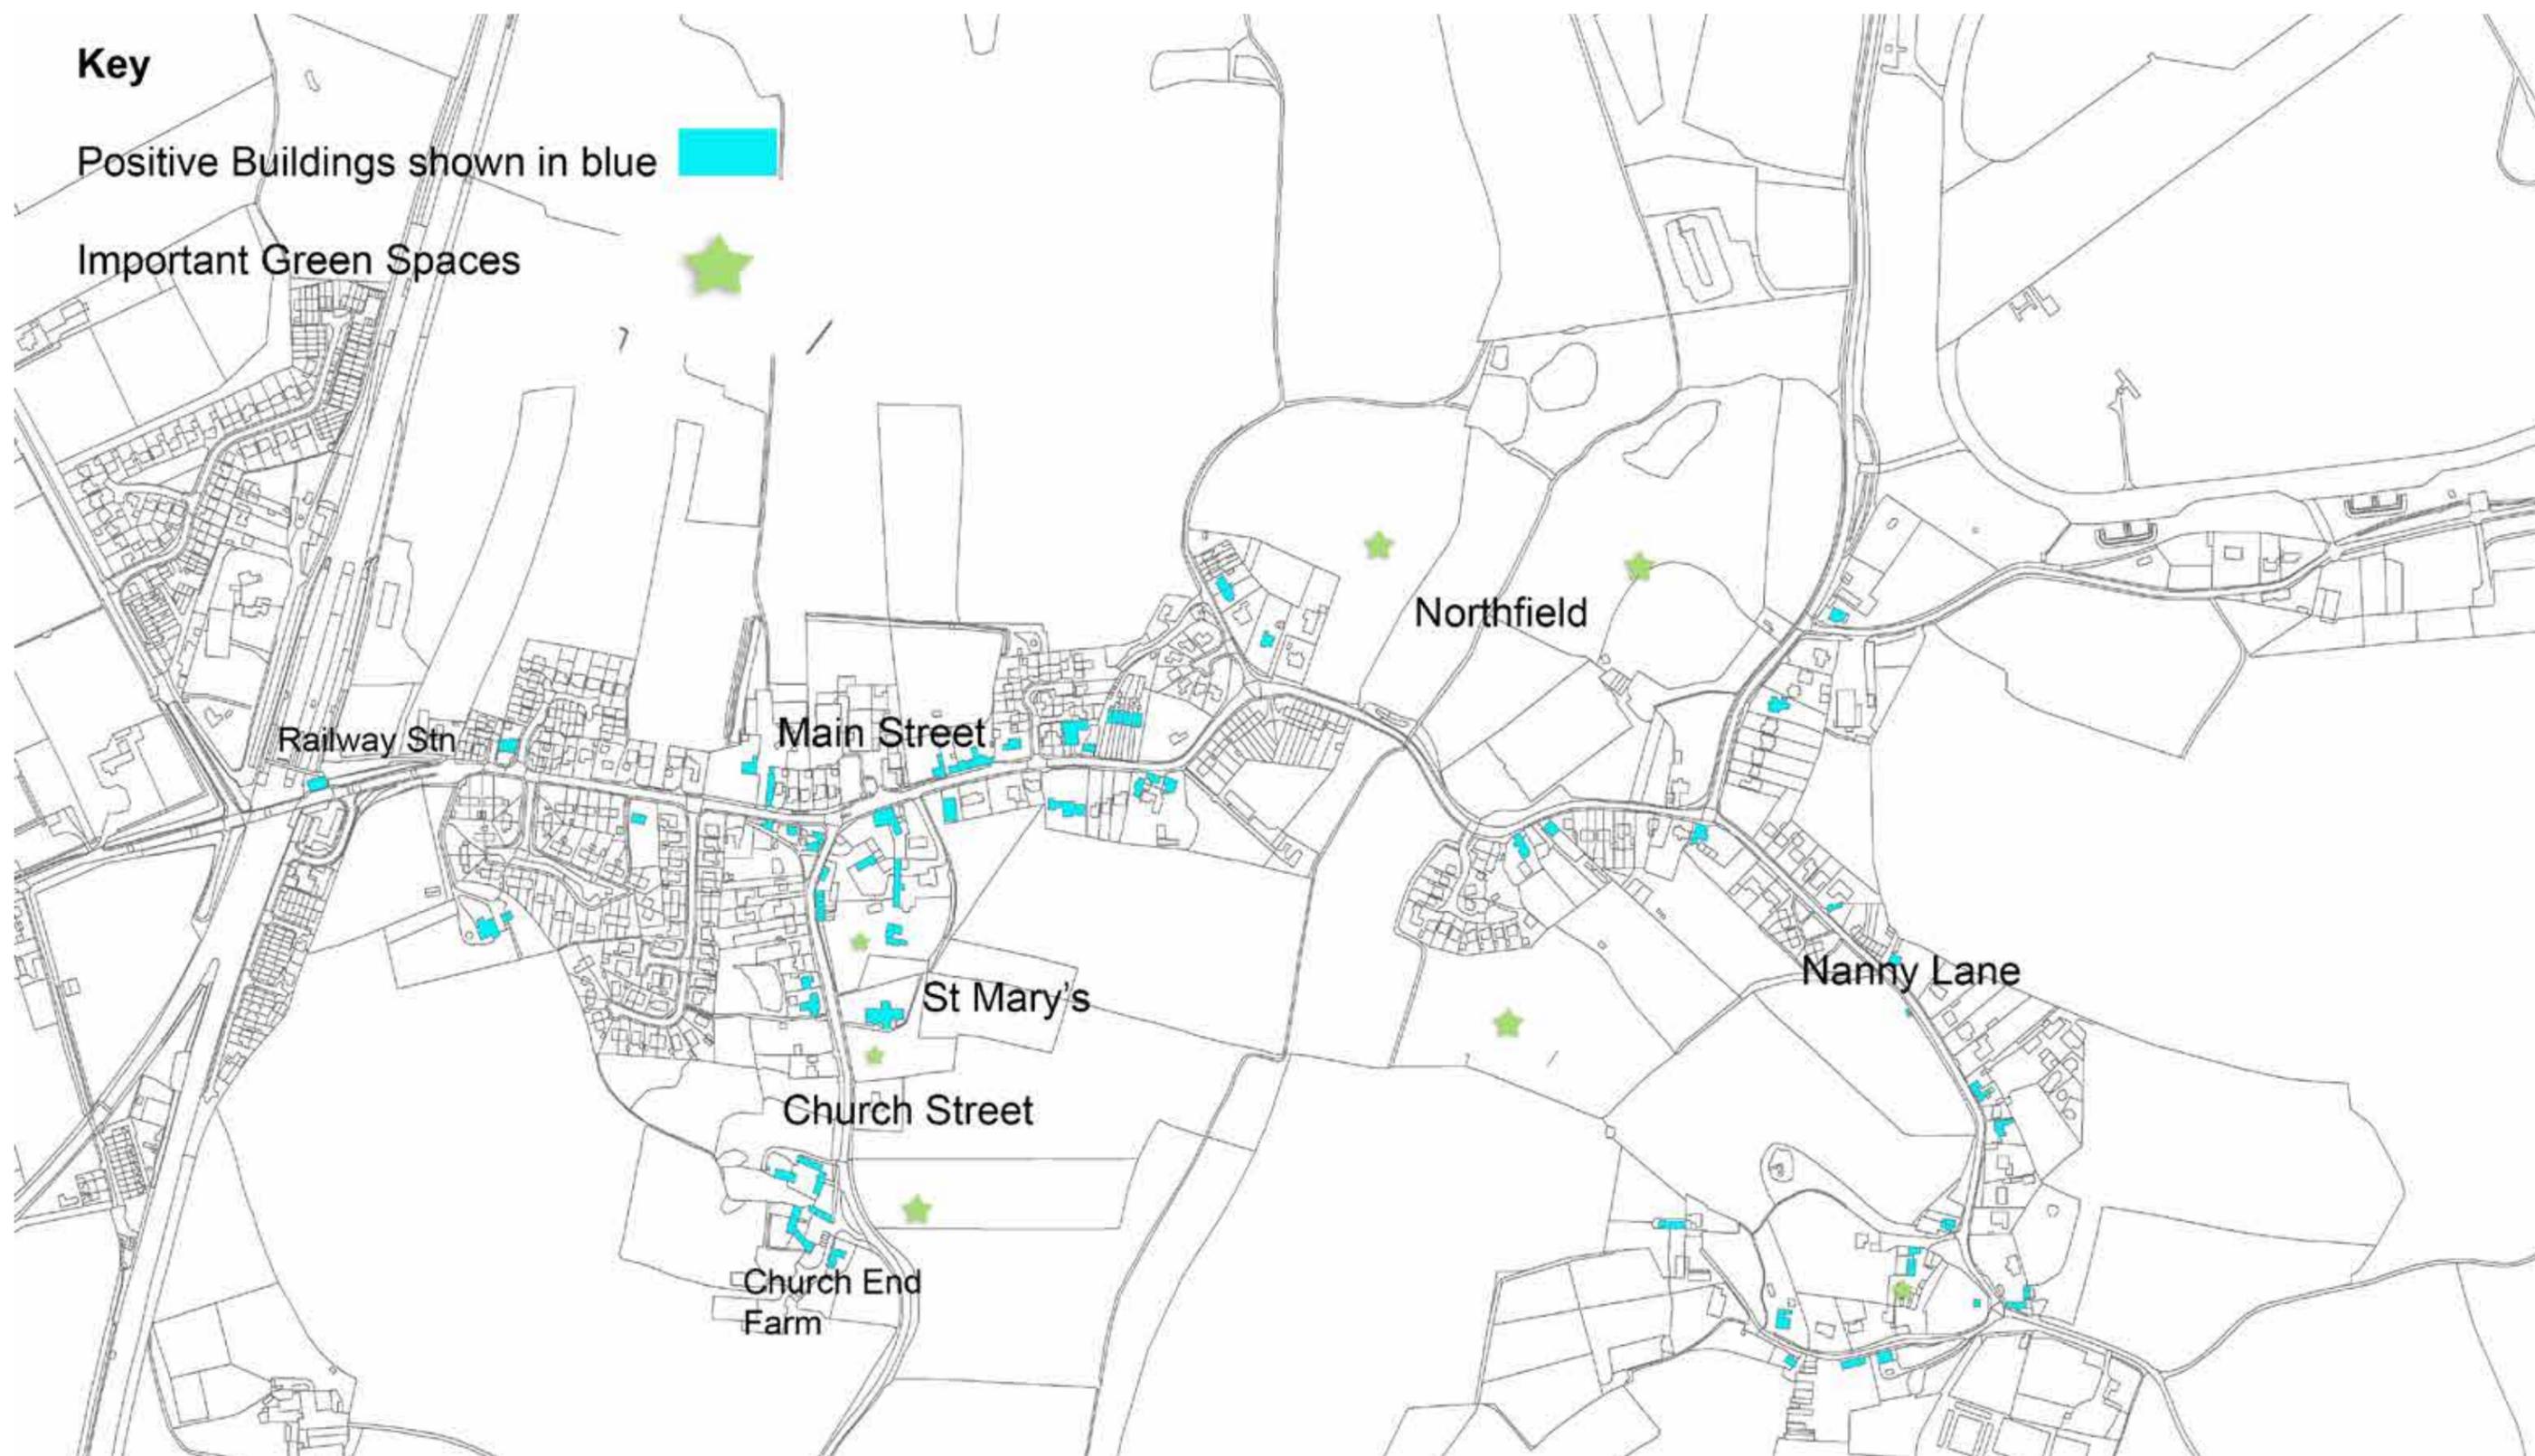
An exercise has been undertaken that attempted to locate 'positive' buildings and features that could help contribute to the appreciation and understanding of the village as an historic place. The mapping of such elements can be used in an attempt to distinguish areas of greater/lesser importance and as such help to determine where potential boundaries could include/exclude.

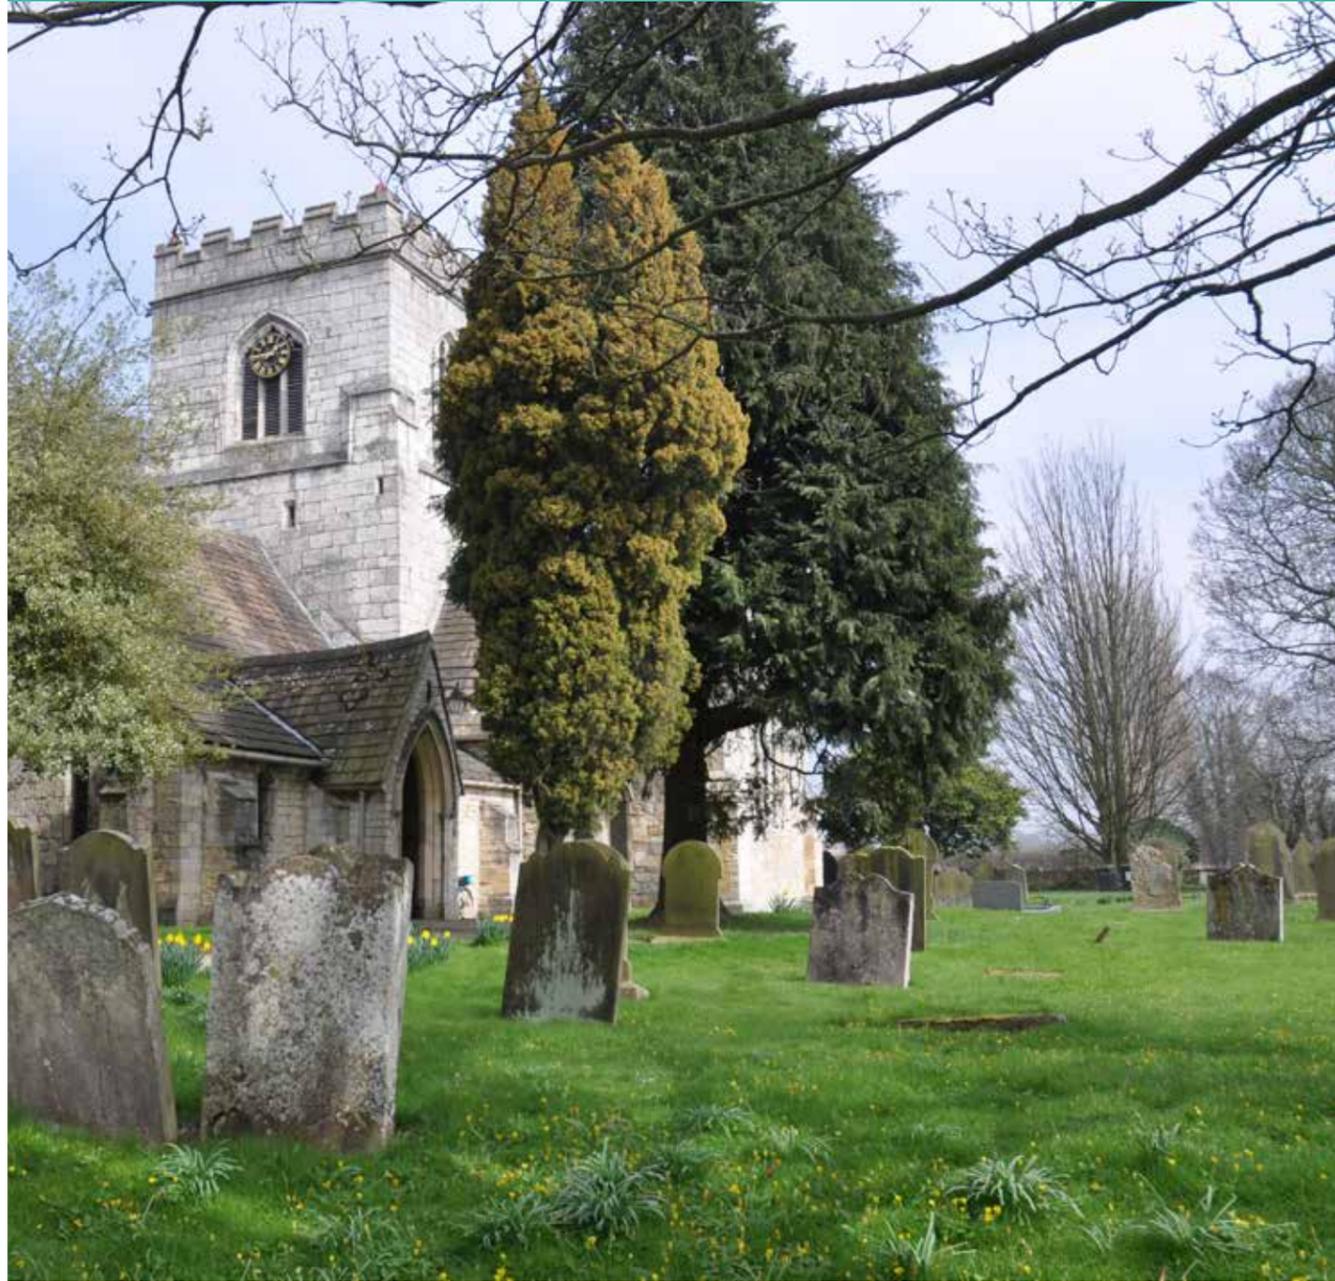
*For Discussion purposes only. Draft Appraisal of Extant Historic Features within the
Village of Church Fenton.
Contact: Andy Graham agraham@selby.gov.uk*
